# APC ALARMS

By David Smith, Field Service Engineer-Trainer

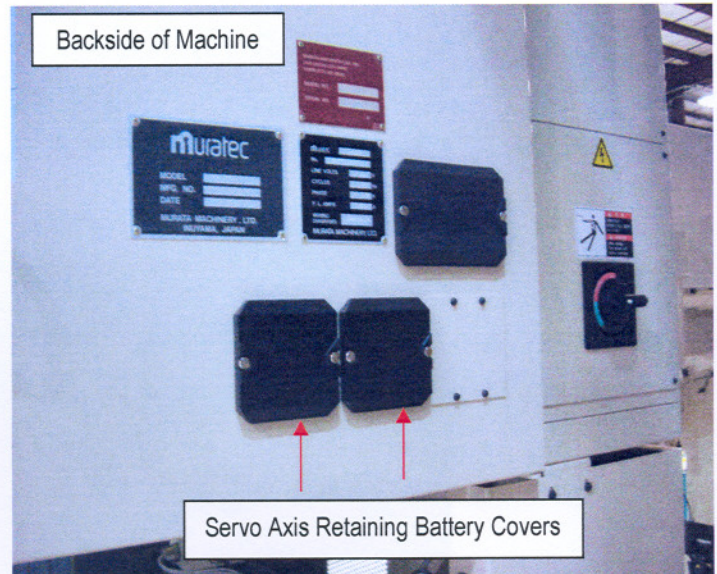
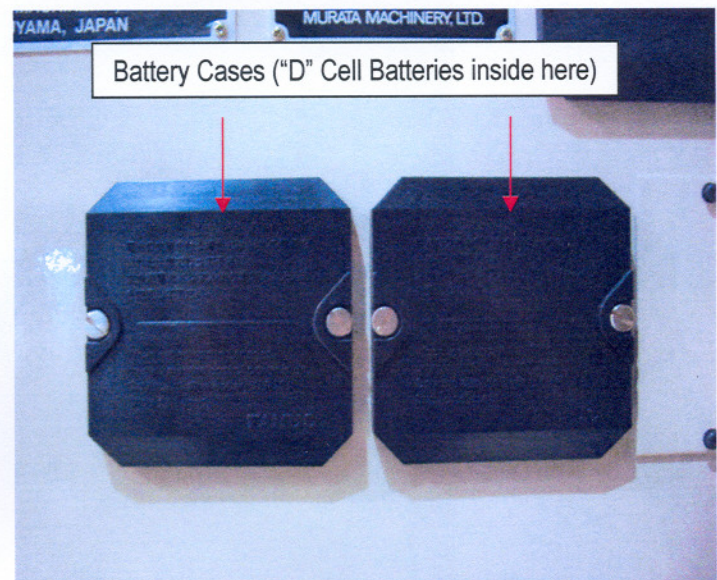
Below are pictures of where the batteries are located and the procedure for changing the batteries.

- 1) Power on NC.
- 2) Open the battery case cover.
- 3) Remove the batteries and replace.
- 4) Close the battery case cover.

**NOTE: ALWAYS REMEMBER TO CHANGE BATTERIES WHILE THE MACHINE IS POWERED UP**
